**DEPARTMENT OF TRANSPORTATION**

Quality Assurance and Source Inspection

Contract #: 04-0120F4Cty: SF/ALA Rte: 80 PM: 13.2/13.9File #: 69.28**WELDING INSPECTION REPORT****Resident Engineer:**Pursell, Gary**Address:** 333 Burma Road**City:** Oakland, CA 94607**Report No:** WIR-002814**Date Inspected:** 04-Jun-2008**Project Name:** SAS Superstructure**OSM Arrival Time:** 630**Prime Contractor:** American Bridge/Fluor Enterprises, a JV**OSM Departure Time:** 1530**Contractor:** Zhenhua Port Machinery Company, Ltd (ZPMC), Changxing Island **Location:** Shanghai,China**CWI Name:** Luan Zhao Gaug**CWI Present:** Yes No**Inspected CWI report:** Yes No N/A**Rod Oven in Use:** Yes No N/A**Electrode to specification:** Yes No N/A**Weld Procedures Followed:** Yes No N/A**Qualified Welders:** Yes No N/A**Verified Joint Fit-up:** Yes No N/A**Approved Drawings:** Yes No N/A**Approved WPS:** Yes No N/A**Delayed / Cancelled:** Yes No N/A**Bridge No:** 34-0006**Component:** OBG**Summary of Items Observed:**

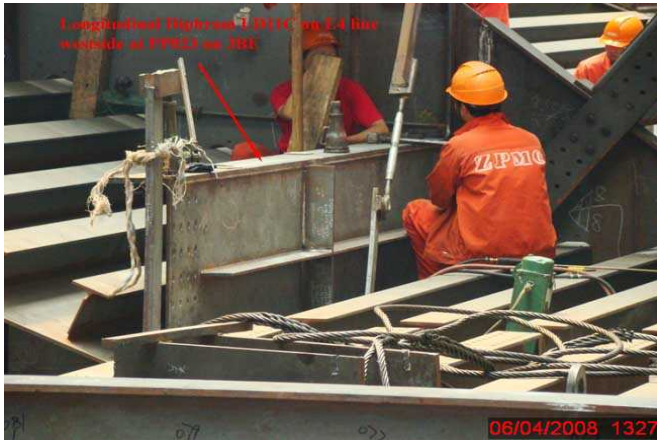
assembly. This floor beam includes both FL1-1's and also the FL2-1 upper and FL2-2 lower onto the assembly.
